ILLINOIS ENVIRONMENTAL PROTECTION AGENCY

MEMORANDUM

SUBJECT: WILL CO. - 19704521 - JOLIET/PROCESS ALLIANCE PARTNERSHIP
PRE D.E. INSPECTION

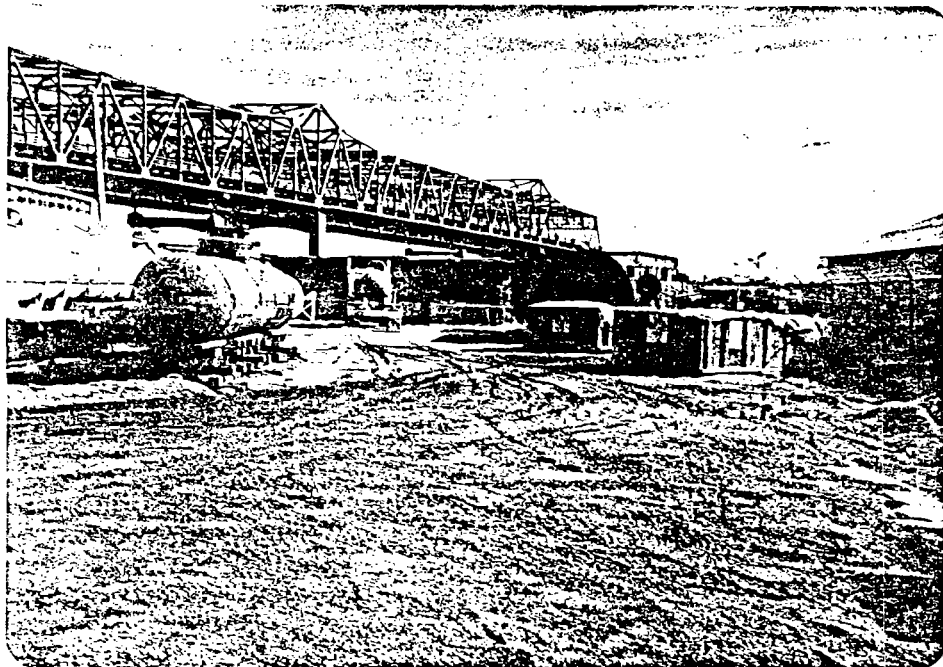
Location: LPC-19704521

Comments: Photograph taken

toward the N.E. from

the S.W.

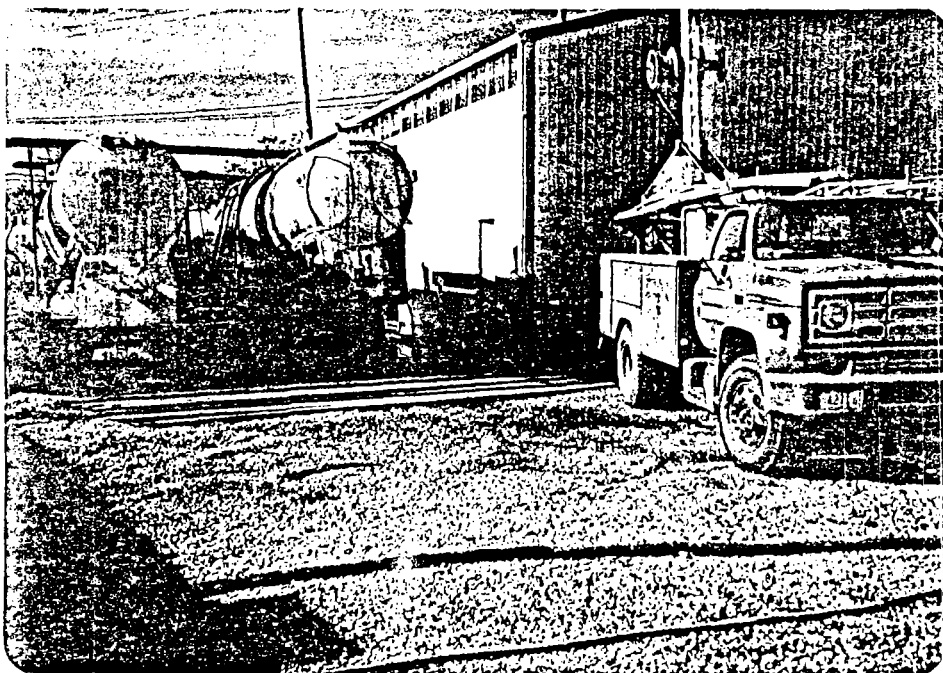
Location: LPC-19704521

Comments: Photograph taken

toward the N.E. from the

S.E.
